# The Structural Reuse of *Pinus Radiata* in New Zealand

A 120 point thesis submitted to  
Victoria University of Wellington  
In fulfilment of the requirements  
Of a Masters of Building Science (MBS)

2018

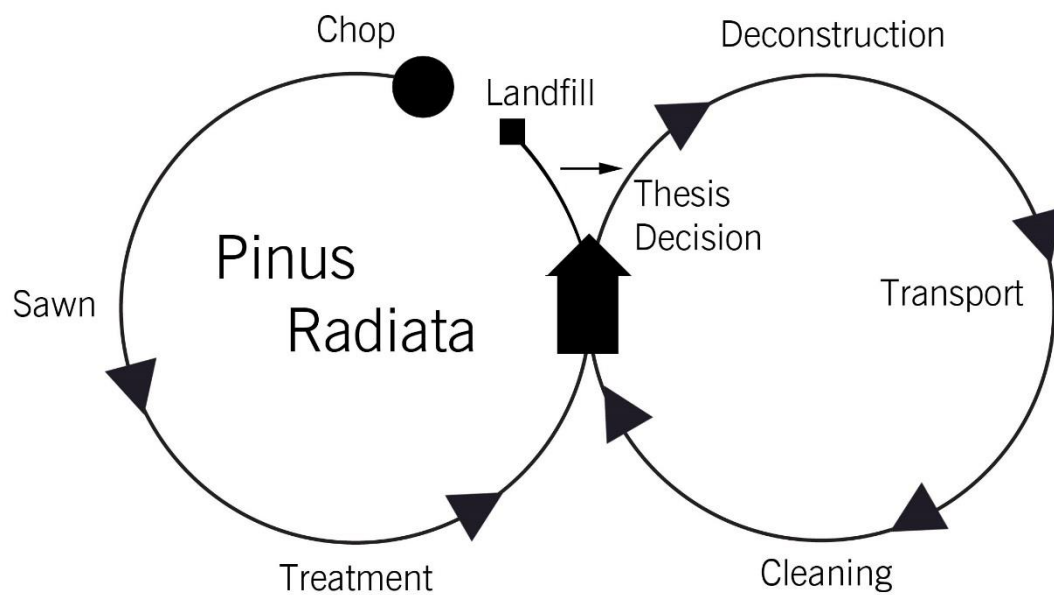
Figure 4 Thesis Model derived from the above information

As explained in Figure 4, this figure 8 system runs off the original circular system. As the above paragraphs suggest this system can be generated through adapting the cycle used for timbers like Rimu. This is explained above in three steps: deconstruction, and transport and cleaning. These three steps can be used where upon clean usable Pine will be generated.

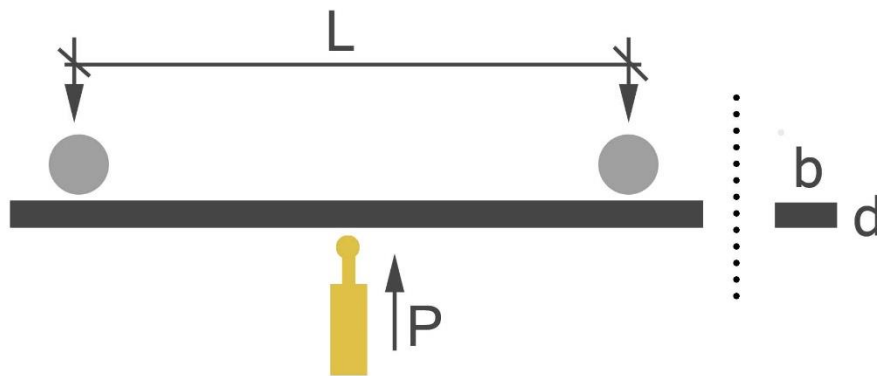
Figure 5 Three point bending test schematic (authors own)

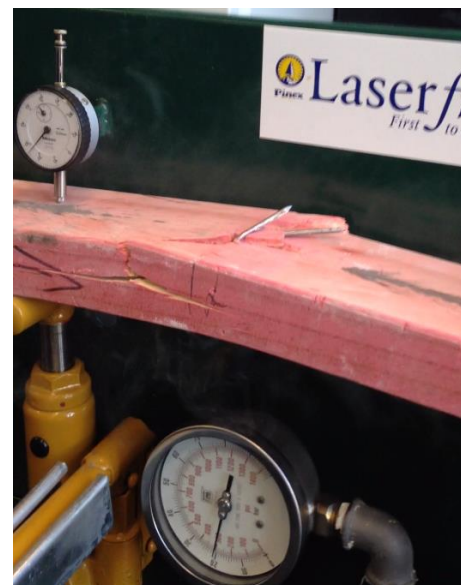
Figure 7 Tested member after breaking point

This illustrated in the above Figure 6 shows where the breaking point was in relation to the ram point load. This break builds on the concept of fixings having a major impact on how a timber member will break when pushed to its ultimate strength.

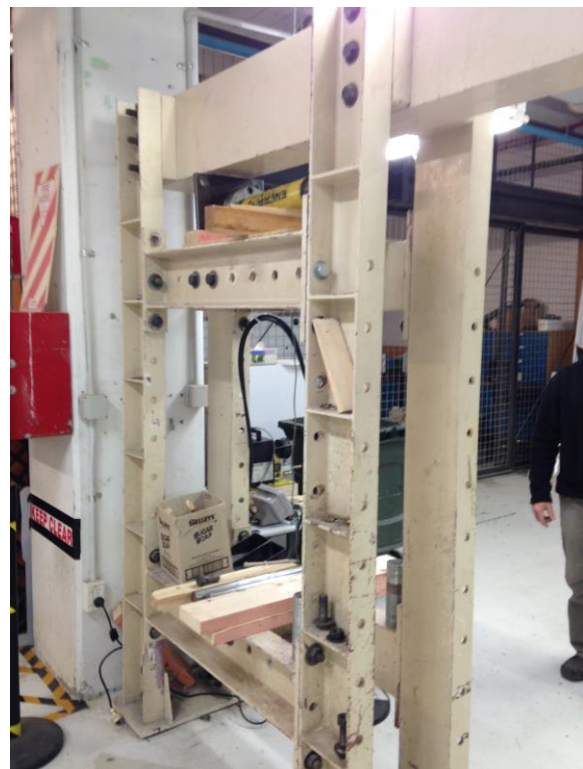
Figure 11 Location for New Rig

Continuing on with the above paragraphs, shown in Figure 11, it can be seen how this rig will function. The distance has been set in accordance with the Plessey Computermatic, and the Eldeco Dart system at 914mm. The reason for the 914mm span, is due to it being converted over from the imperial system, but not wanting to lose all previous testing results. 914mm centre are kept (refer to previous imperial measurement of 3 feet). This enable direct comparison to these test, as this system is used in the sample checking of modern assessments (NZ Wood, 2007).

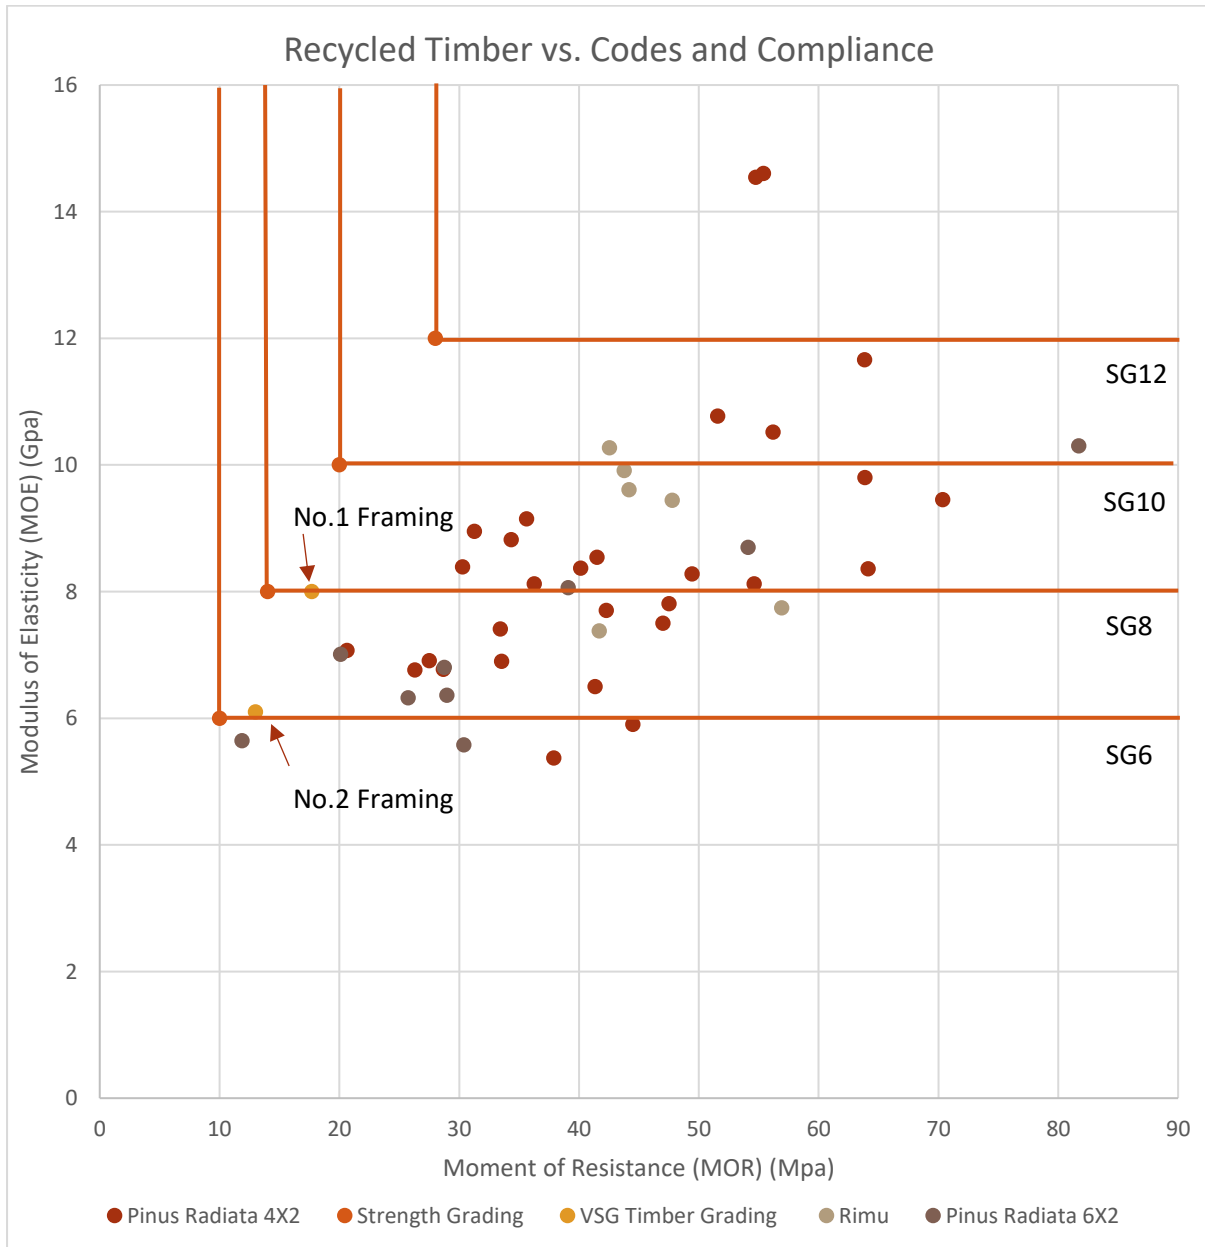
Figure 14 Test results Layout

The above graph is the first outline to understanding the results set out by the three point testing machine. In this graph it is clear to see that the *Pinus* 4x2 and 6x2 are the large plotting, as shown in the colour red and dark green, whilst the Rimu members are plotted in light grey. All of these are mapped against the framing standards, which have been highlighted in orange, making them the focus

As explained in previous sections VSG's grading rules run around Timber Framing grades of 1 and 2. These two grades run along the lowest SG rules, of 6 and 8 as displayed in the above Figure 146. This again is on the bottom two grading rules and again is met by a number of the test subjects.

Over the course of the testing each member has performed itself towards the strength grading criteria. This direct comparison shows in Figure 14 that 91% of all results were within the strength grade requirements, with 55% of those being within the SG8 area, which is the most used strength grade that is sold.

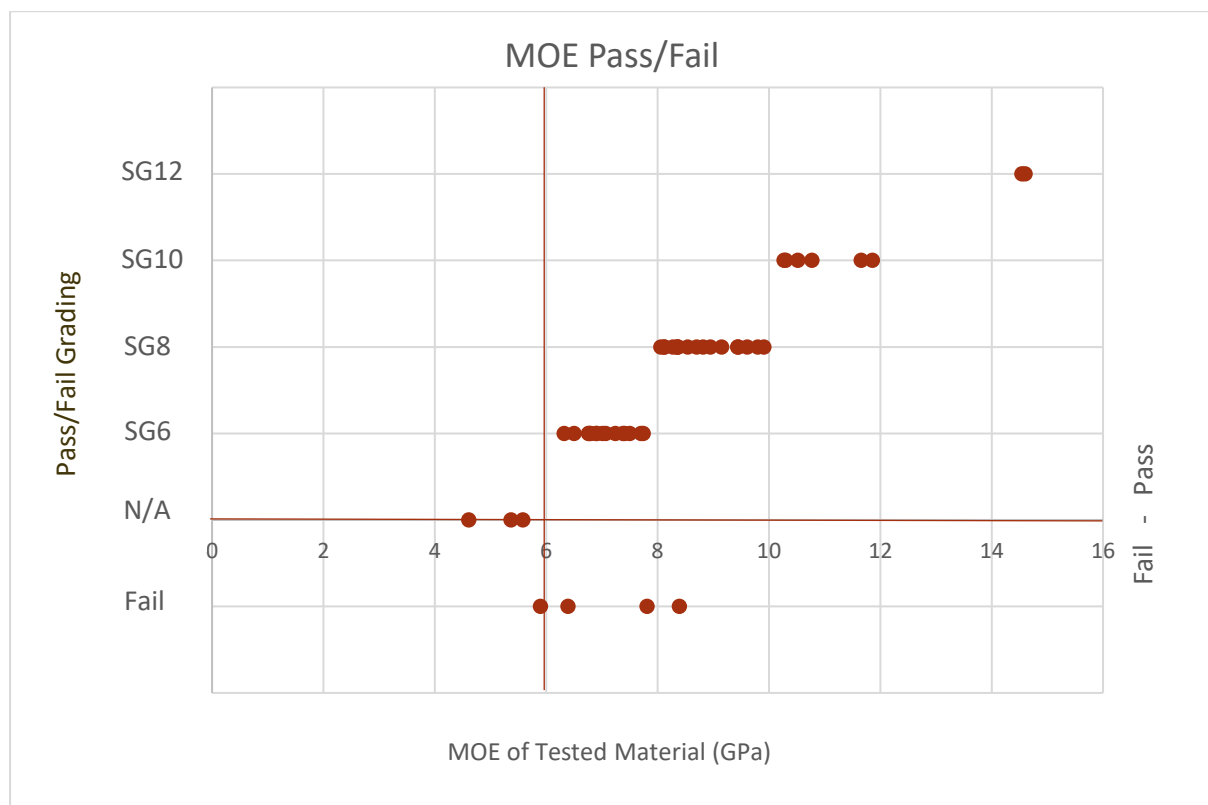
Figure 15 Pass/ Fail grading of tested material

The above graph explains how each material fits into failure or passing Figure 14. As can be seen in the middle of the graph on bar 6 there is a red line which holds the path between a good piece of timber and a bad piece of timber. This although is not bad as the timber that falls below this line is predominantly on the line of N/A, which has been allocated to timber which did not pass the VSG

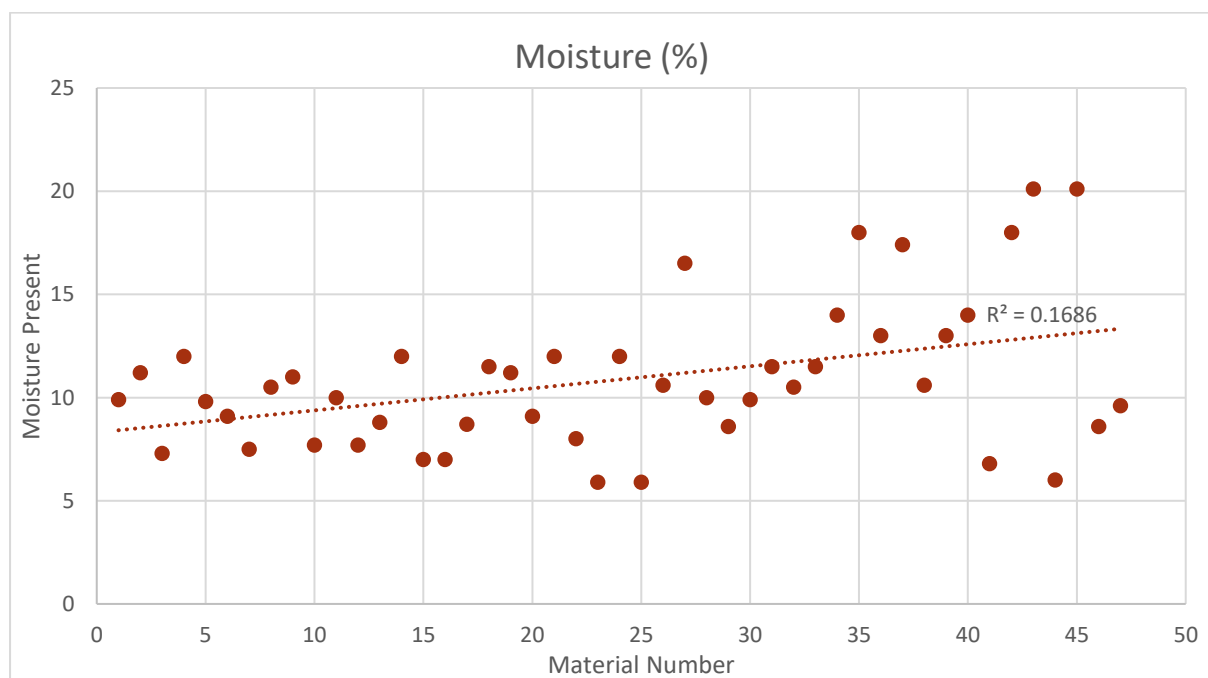
Figure 16 Timber Verses Moisture

One of the ways which could have helped with the ongoing ability for demolition companies to pull aside the correct timber, would be to test it in the building before demolition. Once the data had been tested this did not explain itself as the R<sup>2</sup> value displayed was much lower. This therefore create a situation were as through this tested data, there is no possible way to accurately estimate the strength of a member.

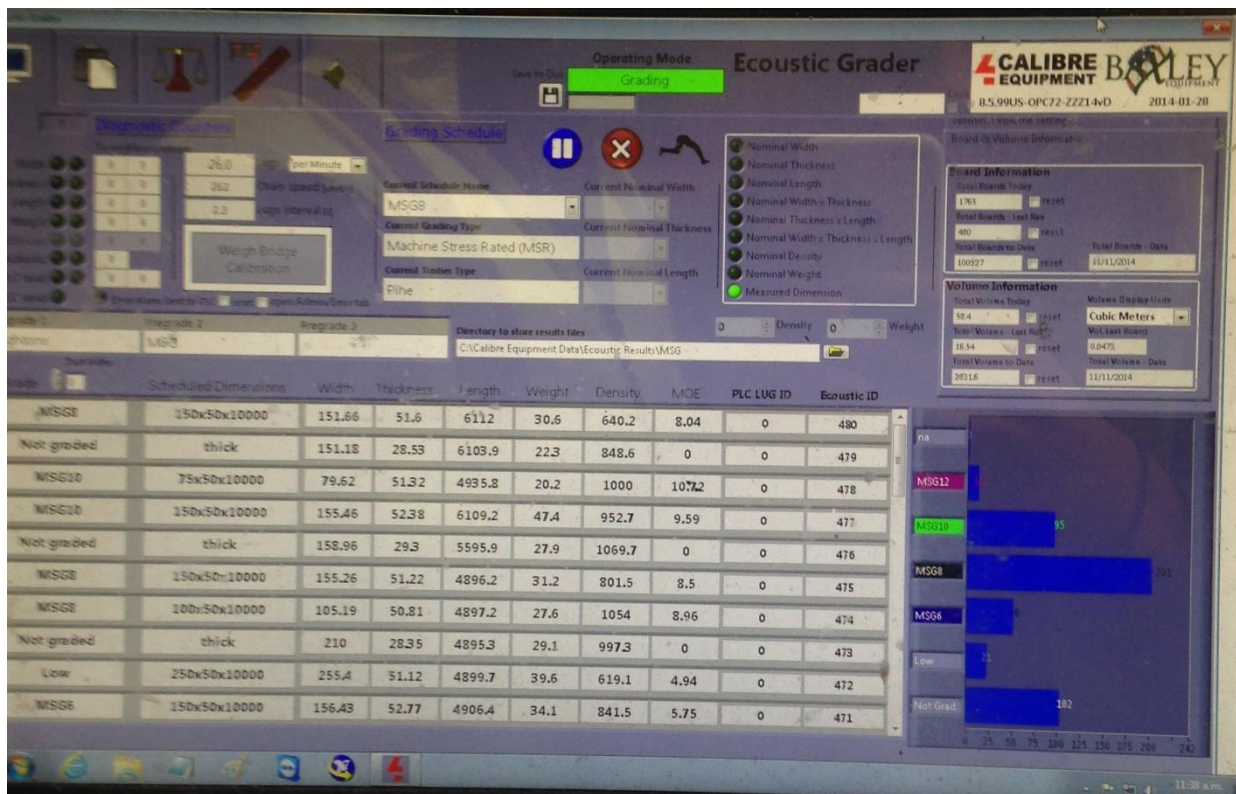
Figure 17 Acoustic Grading output
